N8151-51A 内蔵 DAT 取り扱いの注意事項

856-850719-001-A

N8151-51A Built-In DAT Drive Usage note

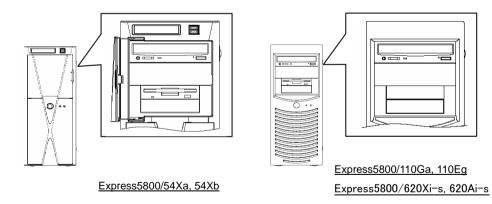
工場出荷時に搭載しているドライブ装置の搭載位置を変更する必要があります。 以下の手順にて搭載位置を変更した後、本内蔵 DAT を取り付けて下さい。

- ① サイドカバー及びフロントマスクを取り外して工場出荷時 5'デバイスベイ上段に 搭載しているドライブを取り外し、下段の空き 5'デバイスベイに取り付ける。 (ドライブの取り付け/取り外しは本体装置の説明書を参照してください。)
- ② 本内蔵 DAT を 5' デバイスベイ上段に取り付ける。

③ ドライブ及び内蔵 DAT の取り付けが終わりましたら、 内部ケーブルがきちんと接続されていることを確認し てフロントマスク、サイドカバーを取り付けてください。

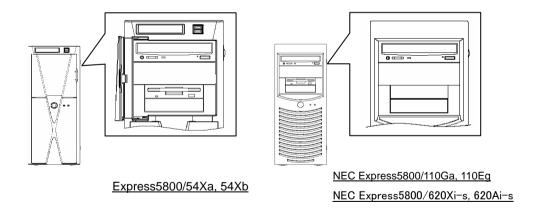
Some models should be required to change the installation position of the factory-installed optical drive for adding this DAT drive. Read this sheet to install the DAT drive.

Follow these steps to reinstall the factory-installed optical drive and add the DAT drive.

- ① Remove the side cover and front panel from your system chassis.
- Remove the factory-installed optical drive from your system and reinstall the drive to the lower bay of the 5-inch device bay (refer to the manual that comes with your system for detail procedures).
- ③ Install the DAT drive into the upper bay of the 5-inch device bay as shown in the figure below (refer to the manual that comes with your system for detail procedures).

- 4 Connect the interface cable and power cable to the drives
- 5 Place the front panel and the side cover back to the chassis.
